# **#88-657-109: LOSS OF ENGINE COOLANT DIAGNOSIS AND REPAIR DESCRIBED - (May 23, 1988)**

**VEHICLES AFFECTED: 1987-88 VEHICLES EQUIPPED WITH  
5.0L AND 5.7L ENGINES (PASSENGER CAR VIN E, F, G, H, 6,  
8) OR (TRUCK VIN H, K, M)**

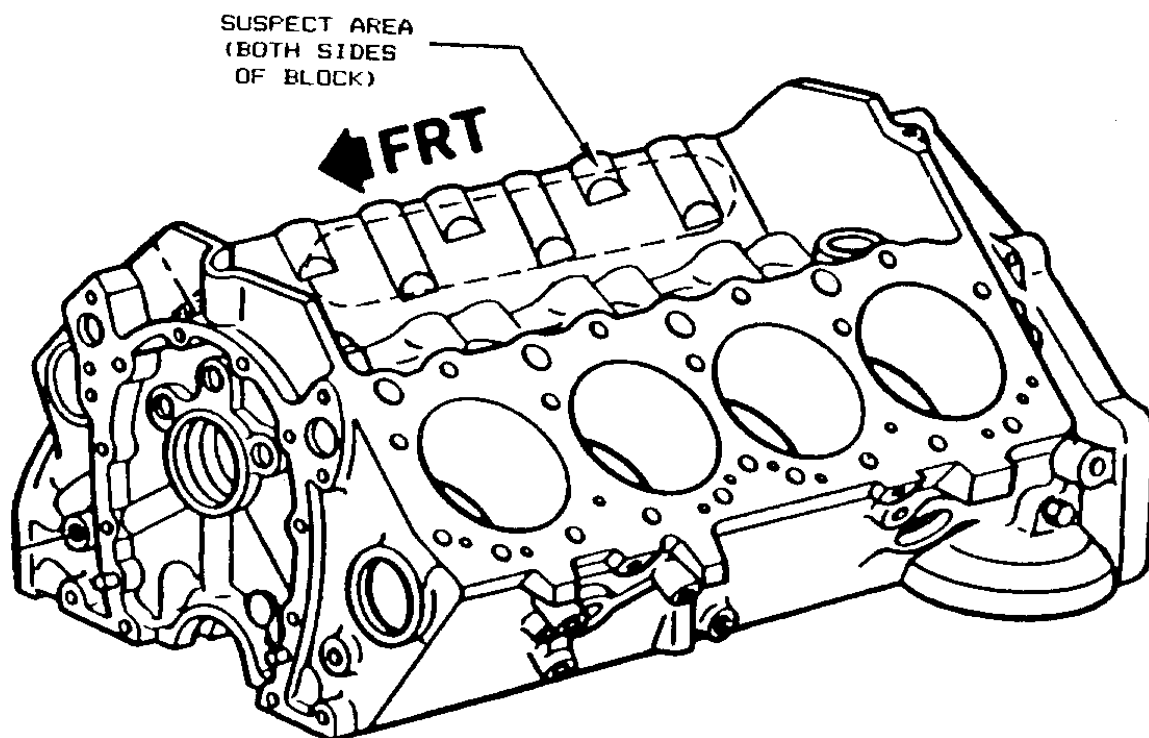
FIGURE 1

Inspection can be accomplished in two manners. The first method involves removal of the intake manifold and direct visual inspection of the walls of the galley. Particular attention should be given to the areas of the galley within the first few inches below the deck (as Illustrated). A casting parting line may also be evident in this area and should not be mistaken for a crack. If an area looks suspect, cracks can be more positively identified by use of a commercially available penetrant dye such as magnaflux "spotcheck".

An alternate inspection procedure, effective in many cases, involves removal of the valve covers and inspection of the galley walls by shining a flashlight through the holes in the cylinder head into the galley area and looking for a small buildup of greenish-brown deposits along the face of the wall. A typical crack (and therefore line of deposits) might be two or more inches in length and run approximately parallel to the deck. If no deposit line is evident, but indications of the presence of coolant in the galley area or a light brown creamy residue on the underside of the valve cover is seen during this inspection, the intake manifold gaskets should be replaced and the walls of the galley should be thoroughly inspected for cracks with the intake manifold removed. In addition, the underside of the intake manifold should be inspected for signs of porosity.

On vehicles equipped with non-roller lifters, if a crack is found in the galley wall and/or there is evidence of coolant contamination of the oil (as previously described) , the lifter feet and camshaft lobes should be inspected for signs of distress and replaced as necessary. Distress can be identified on the cam by one or more worn lobes with an even wear pattern across the face of the lobe. Distress can be identified on the lifter feet by a less smooth (scratchy, non-reflective) surface finish.

After an internal coolant leak is repaired, the oil and oil filter should be replaced.
