#87-650-101: LACK OF WARM AIR FROM HEATER CHECK INTAKE MANIFOLD PASSAGE - (Oct 23, 1986)

VEHICLES AFFECTED: 1987 'R' AND 'V' TRUCK WITH 5.0L L03 AND 5.7L L05 ENGINES (VIN CODES H AND K)

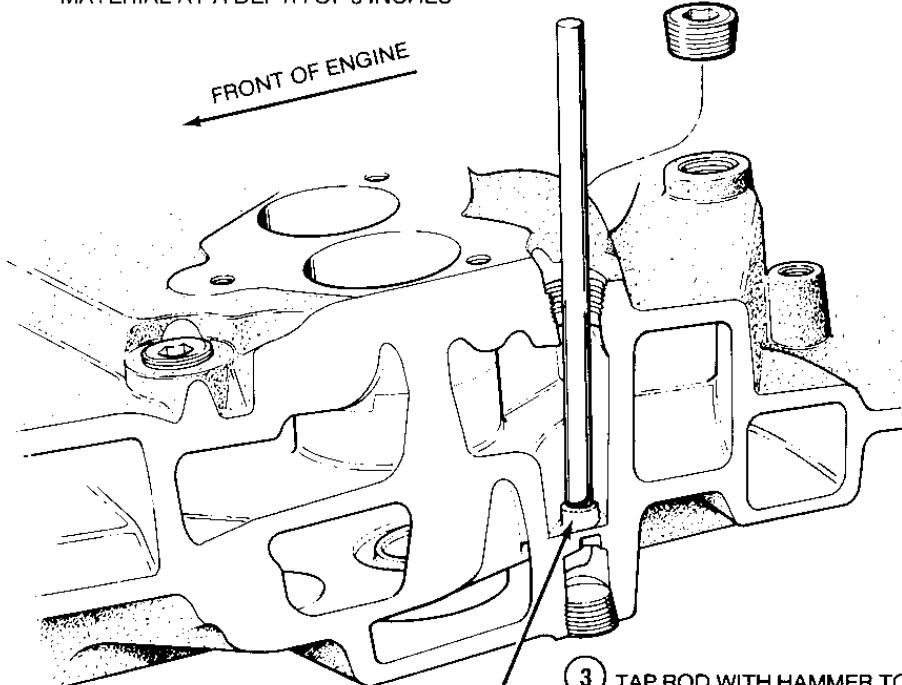
Figure No. 1

Early production 'R' and 'V' trucks equipped with L03 and L05 engines that were built at the Janesville, plant may have a blockage in the inlet manifold that could restrict coolant flow to the heater core. This could lead to customer comments of low or no heat from the vehicle heater.

**NOTE: SECTIONED VIEW OF INLET
MANIFOLD AS VIEWED FROM
LEFT SIDE OF ENGINE.**

MANIFOLD REPAIR PROCEDURE

- ② INSERT A 7/16" DIAMETER ROD THROUGH PLUG OPENING. ROD WILL CONTACT BLOCKAGE MATERIAL AT A DEPTH OF 3 INCHES

- ① REMOVE PLUG FROM MANIFOLD USING 3/8" ALLEN WRENCH. PLUG IS LOCATED TO THE LEFT AND REARWARD OF TBI UNIT.

- ③ TAP ROD WITH HAMMER TO REMOVE BLOCKAGE MATERIAL.

- ④ REMOVE BROKEN MATERIAL USING A SHOP VACUUM AND 5/8" DIAMETER SUCTION HOSE.
